APPENDIX D

SITE PHOTOGRAPHS

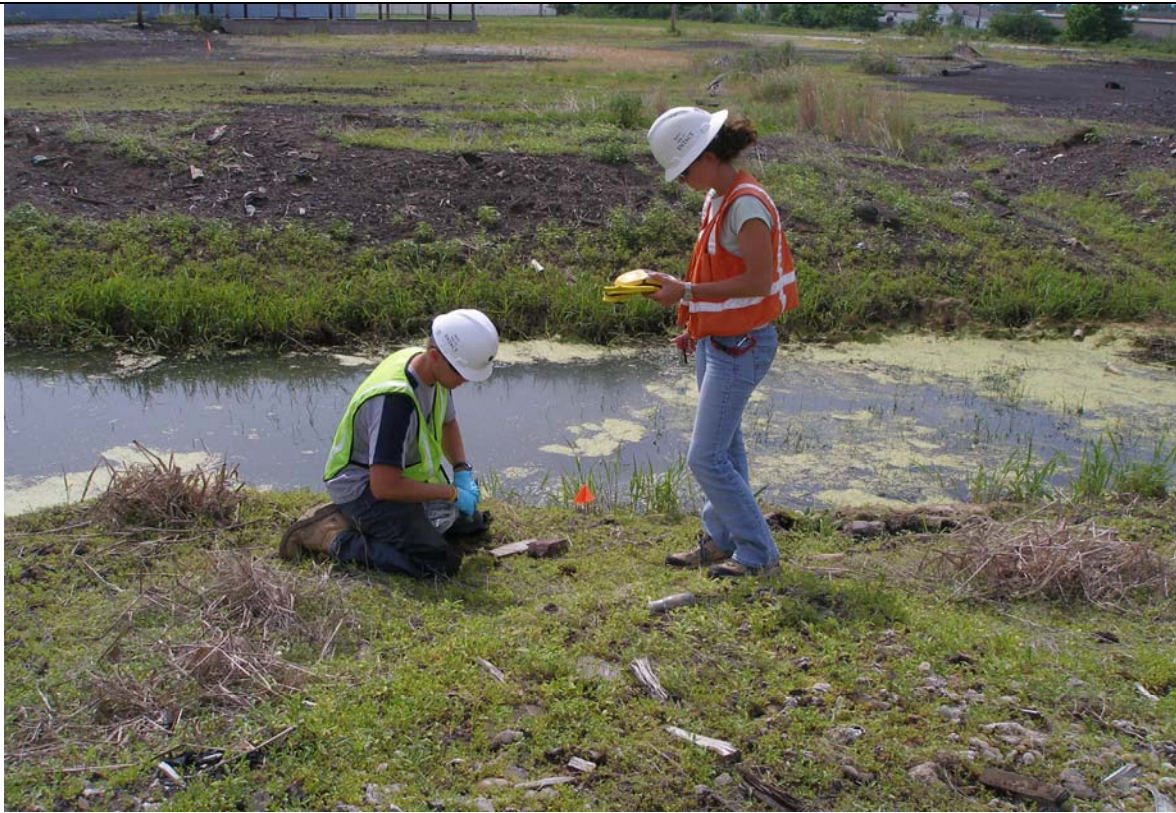
PHOTOGRAPH:		PHOTOGRAPHER:	Melanie Gotto
DATE/TIME:	6/8/2006	10:12 AM	
PROJECT:	Remedial Investigation Report for the Old American Zinc Plant Site, Fairmont City, Illinois		
SUBJECT:	Surface sampling collection activities and sampling locate using GPS.

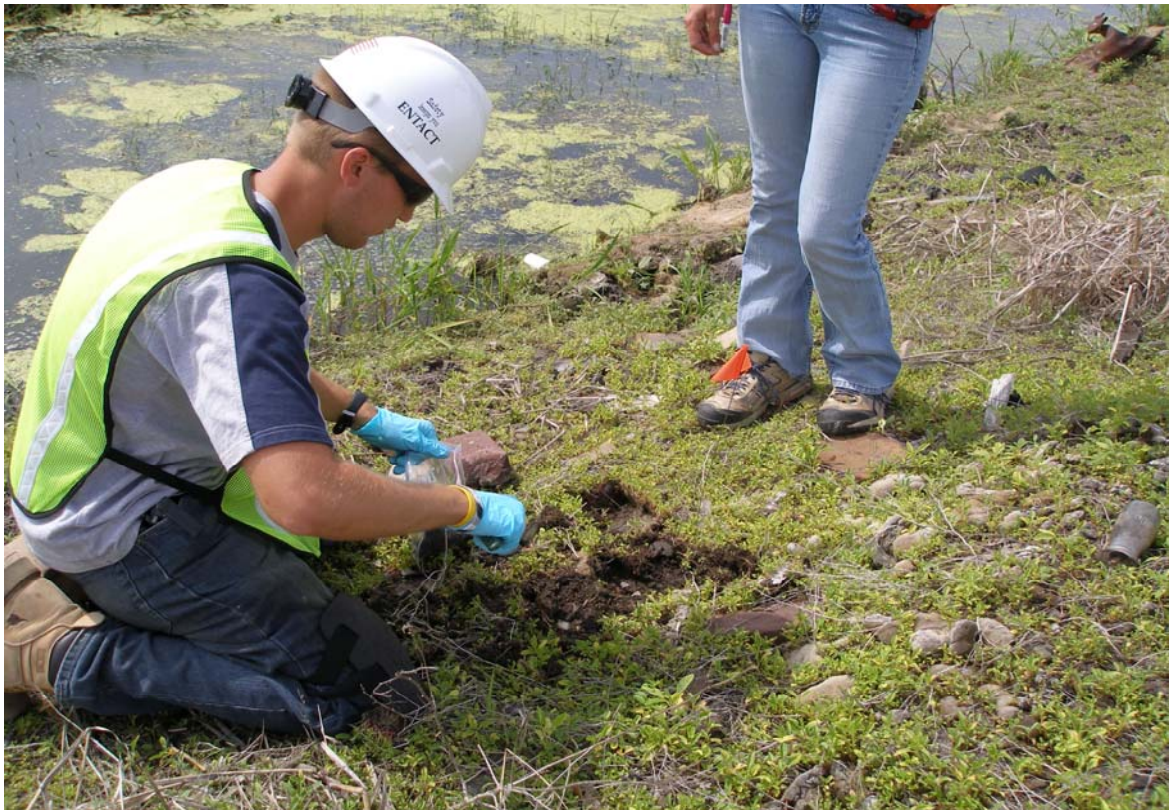
PHOTOGRAPH:		PHOTOGRAPHER:	Melanie Gotto
DATE/TIME:	6/8/2006	10:14 AM	
PROJECT:	Remedial Investigation Report for the Old American Zinc Plant Site, Fairmont City, Illinois		
SUBJECT:	Surface sample collection from upper one inch of material over one-foot square area using stainless-steel trowel

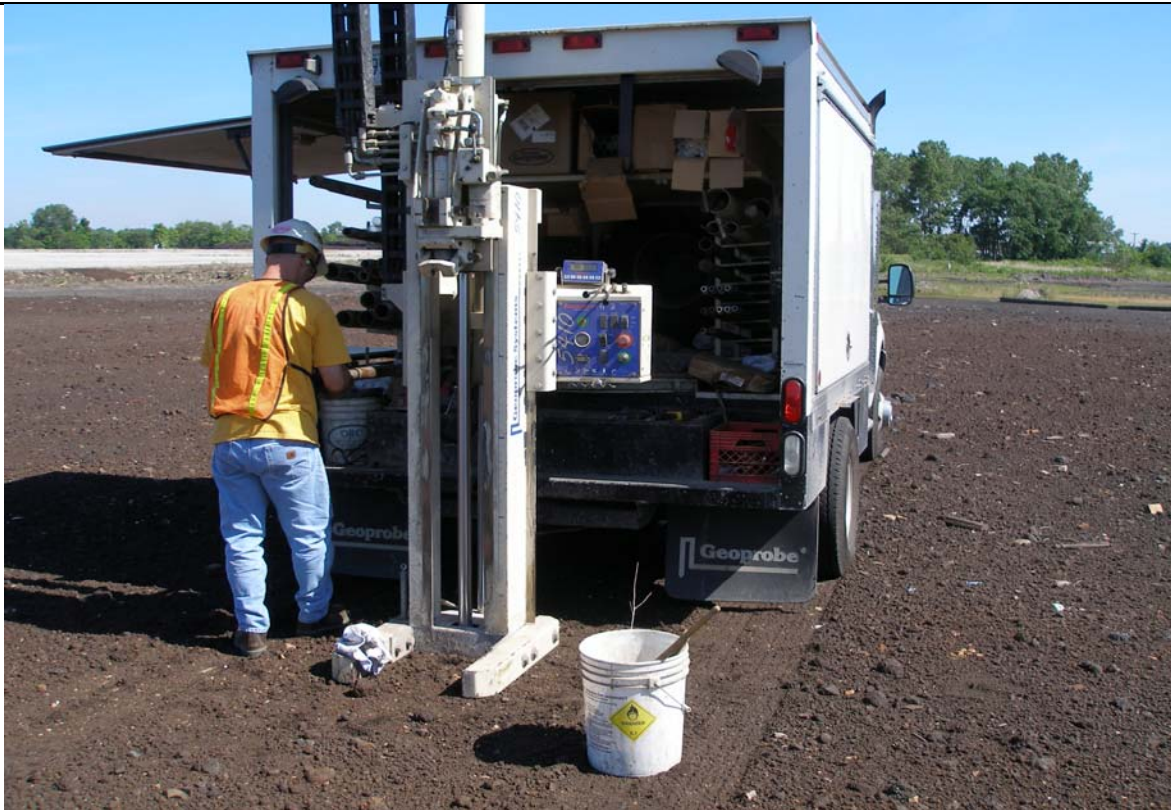
PHOTOGRAPH:		PHOTOGRAPHER:	Melanie Gotto
DATE/TIME:	6/5/2006	9:59 AM	
PROJECT:	Remedial Investigation Report for the Old American Zinc Plant Site, Fairmont City, Illinois		
SUBJECT:	Subsurface sampling activities using a Geoprobe.

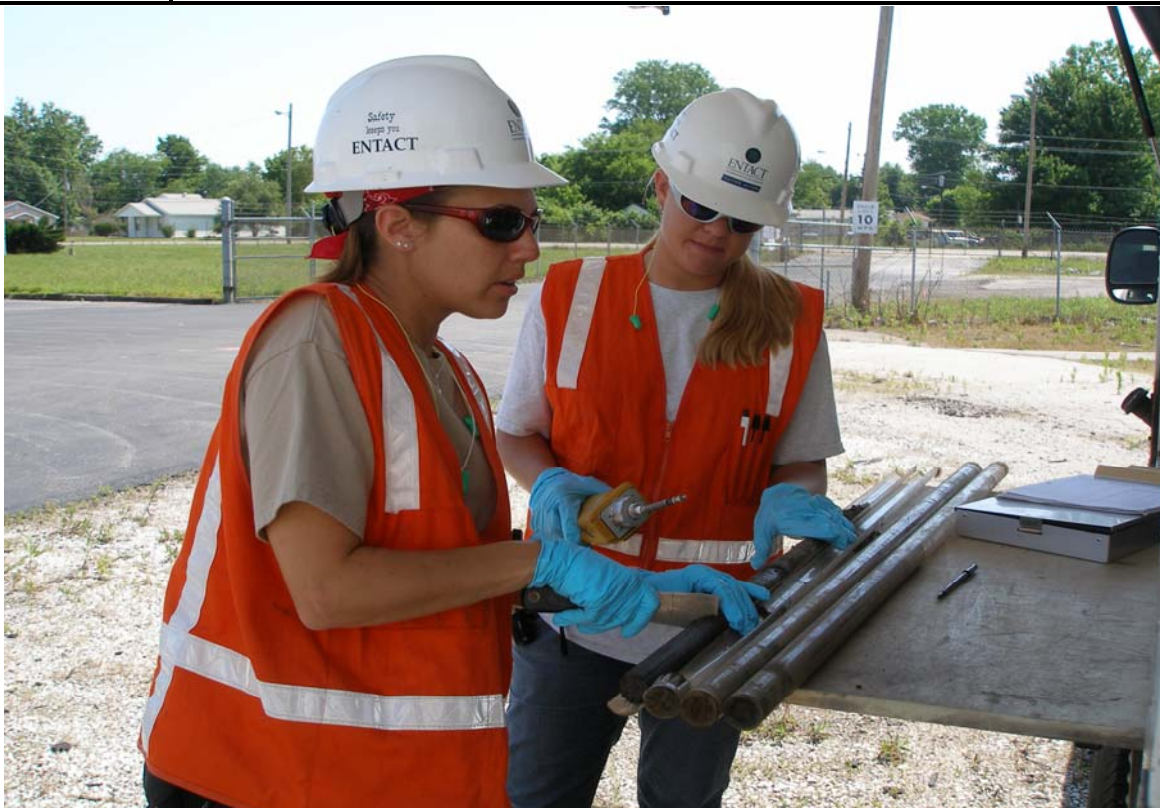
PHOTOGRAPH:		PHOTOGRAPHER:	Melanie Gotto
DATE/TIME:	6/14/2006	10:47 AM	
PROJECT:	Remedial Investigation Report for the Old American Zinc Plant Site, Fairmont City, Illinois		
SUBJECT:	Geologic logging of borehole and PID analysis of Macro-Core sampler from Geoprobe activities.

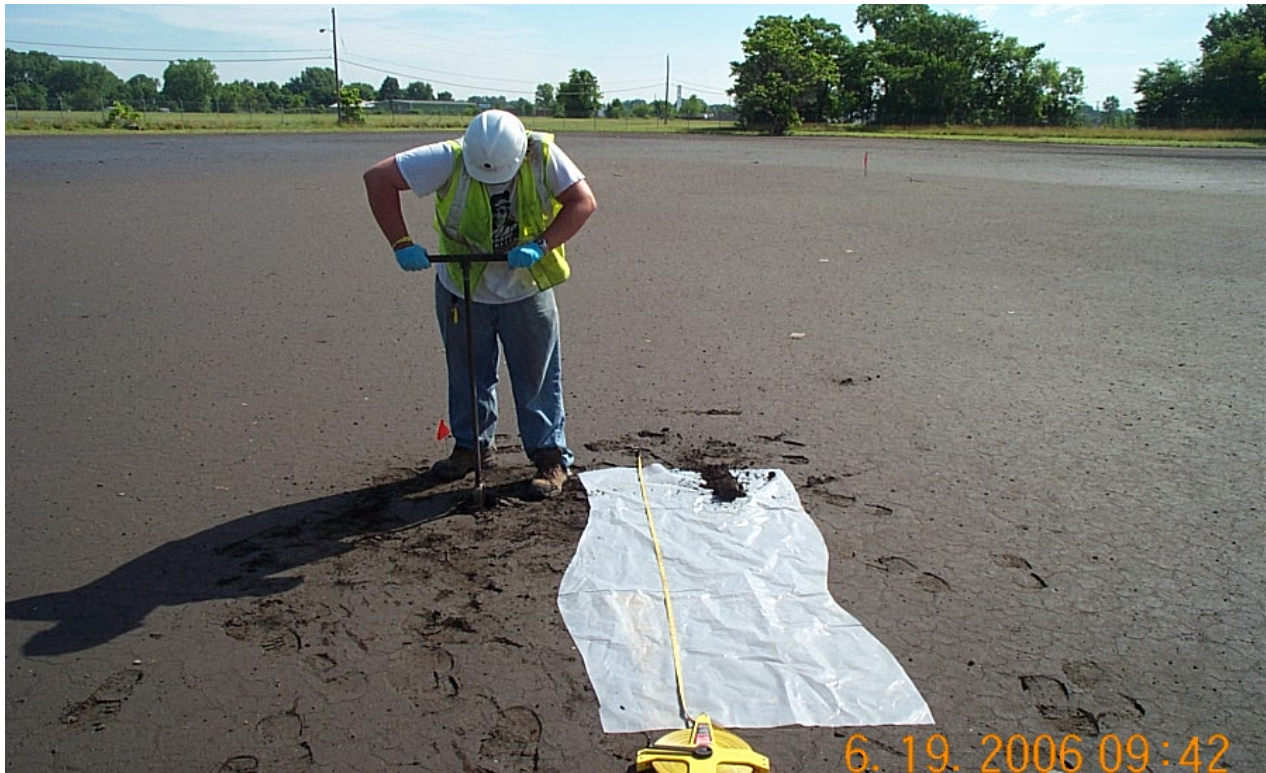
PHOTOGRAPH:		PHOTOGRAPHER:	Mike Carlson
DATE/TIME:	6/19/2006	9:42 AM	
PROJECT:	Remedial Investigation Report for the Old American Zinc Plant Site, Fairmont City, Illinois		
SUBJECT:	Hand auger sampling conducted in the low-lying unvegetated area located at the northern boundary of the Facility.

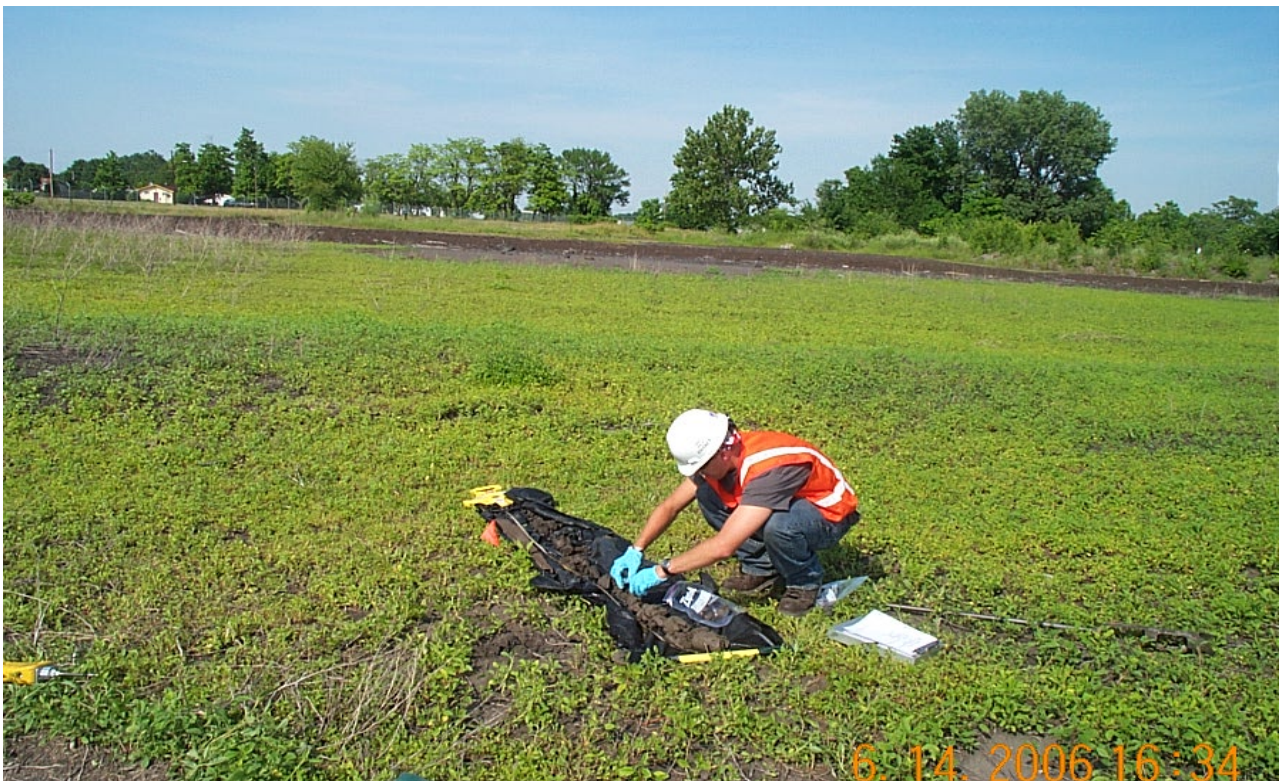
PHOTOGRAPH:		PHOTOGRAPHER:	Mike Carlson
DATE/TIME:	6/14/2006	4:34 PM	
PROJECT:	Remedial Investigation Report for the Old American Zinc Plant Site, Fairmont City, Illinois		
SUBJECT:	Materials retrieved via hand augering activities were placed on plastic in sequence for identification and sampling.

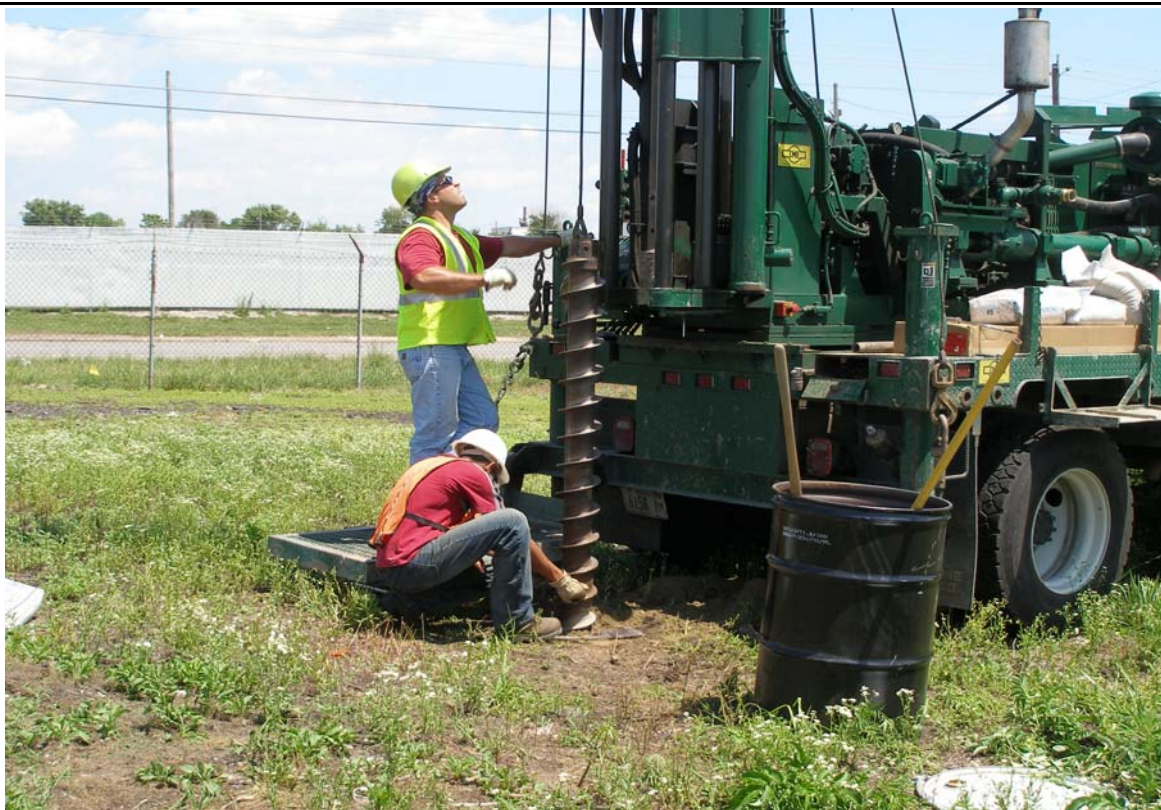
PHOTOGRAPH:		PHOTOGRAPHER:	Melanie Gotto
DATE/TIME:	6/19/2006	2:03 PM	
PROJECT:	Remedial Investigation Report for the Old American Zinc Plant Site, Fairmont City, Illinois		
SUBJECT:	Installation of monitoring well MW-02 using 4.25-inch inner diameter, hollow-stemmed auger.

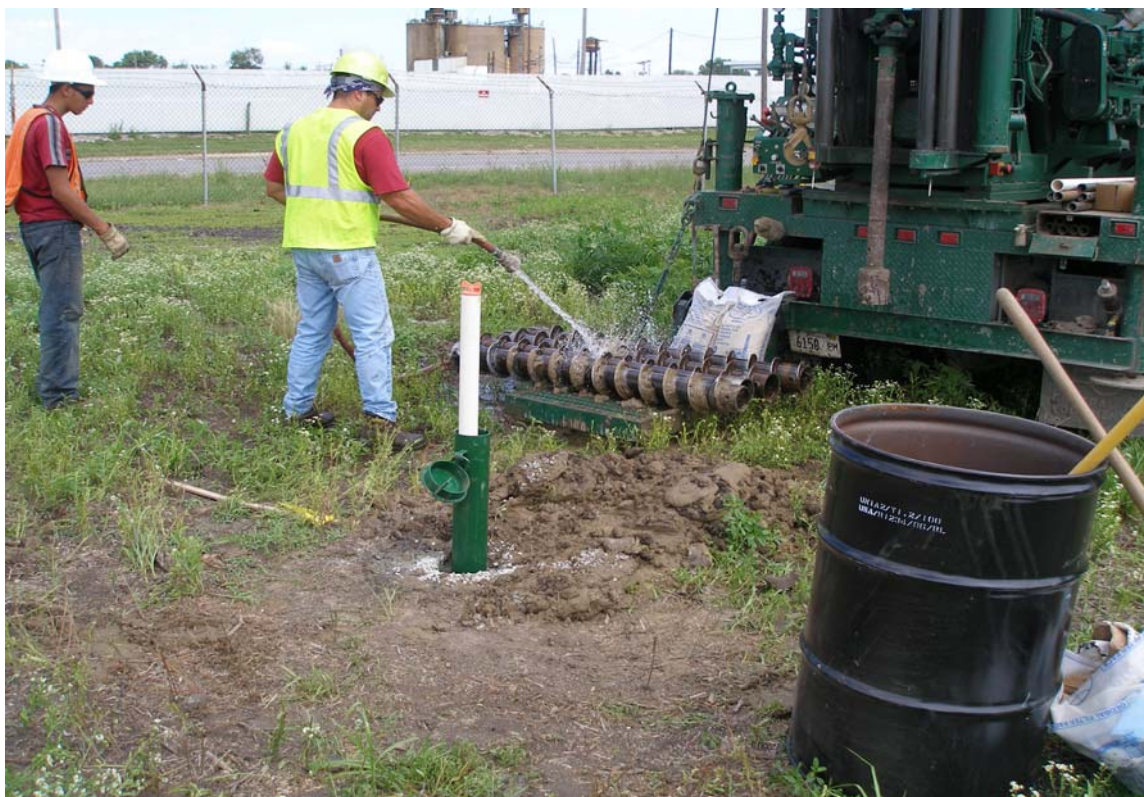
PHOTOGRAPH:		PHOTOGRAPHER:	Melanie Gotto
DATE/TIME:	6/19/2006	2:54 PM	
PROJECT:	Remedial Investigation Report for the Old American Zinc Plant Site, Fairmont City, Illinois		
SUBJECT:	Decontamination of augers and the near completion of installing MW-02.

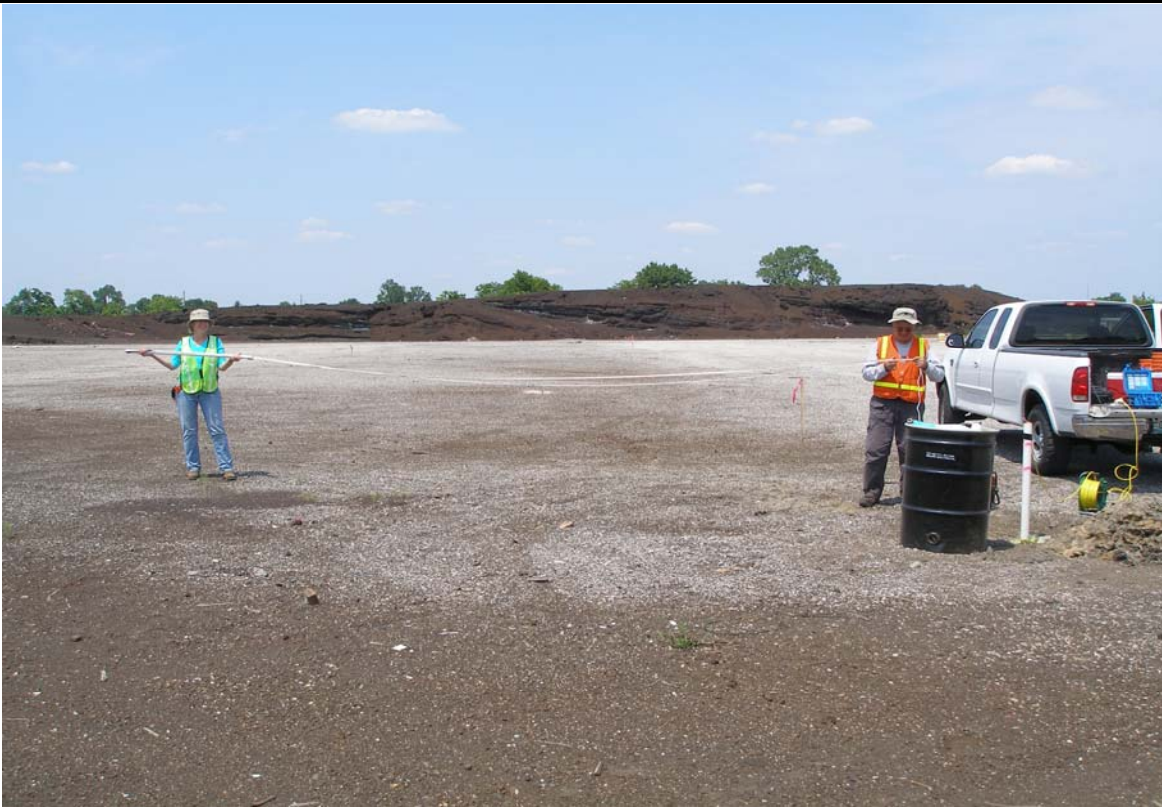
PHOTOGRAPH:		PHOTOGRAPHER:	Melanie Gotto
DATE/TIME:	7/7/2006	2:02 PM	
PROJECT:	Remedial Investigation Report for the Old American Zinc Plant Site, Fairmont City, Illinois		
SUBJECT:	Slug test setup at P-03 utilizing a 36-inch, sand-filled PVC slug

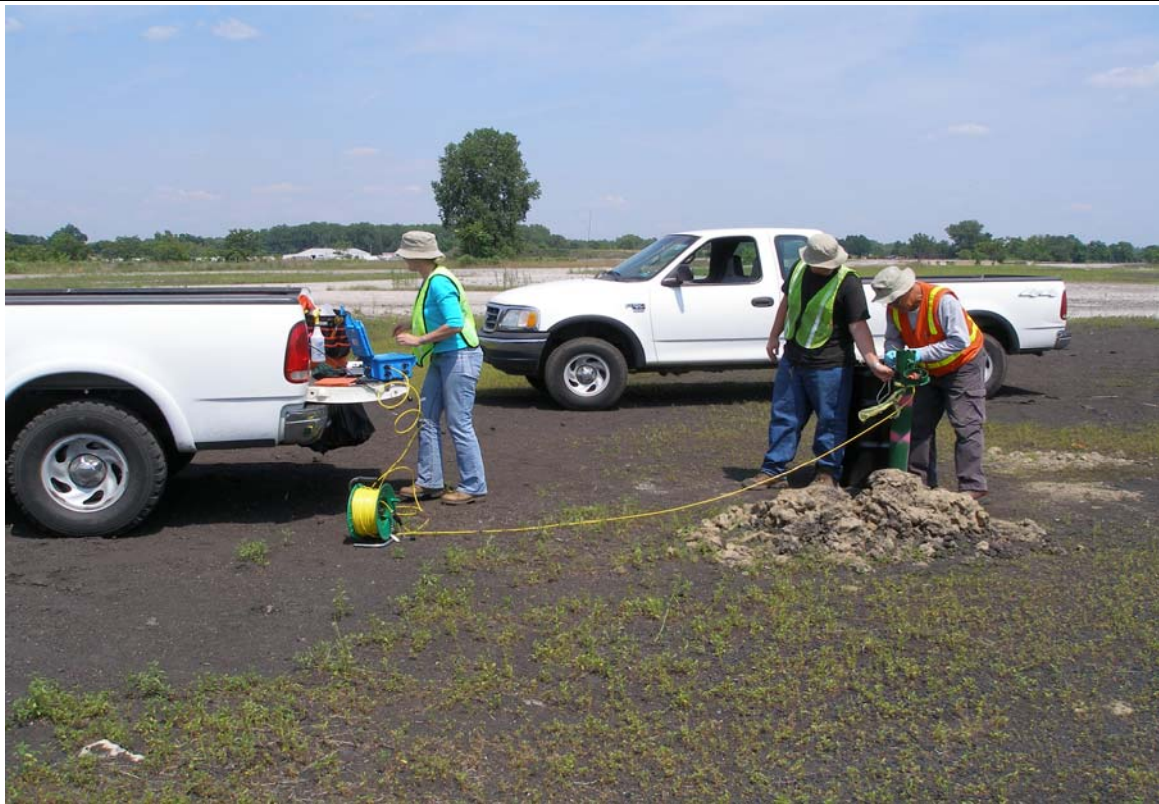
PHOTOGRAPH:		PHOTOGRAPHER:	Melanie Gotto
DATE/TIME:	7/7/2006	11:30 AM	
PROJECT:	Remedial Investigation Report for the Old American Zinc Plant Site, Fairmont City, Illinois		
SUBJECT:	Slug testing activities utilizing the Hermit 3000 datalogger and transducer.

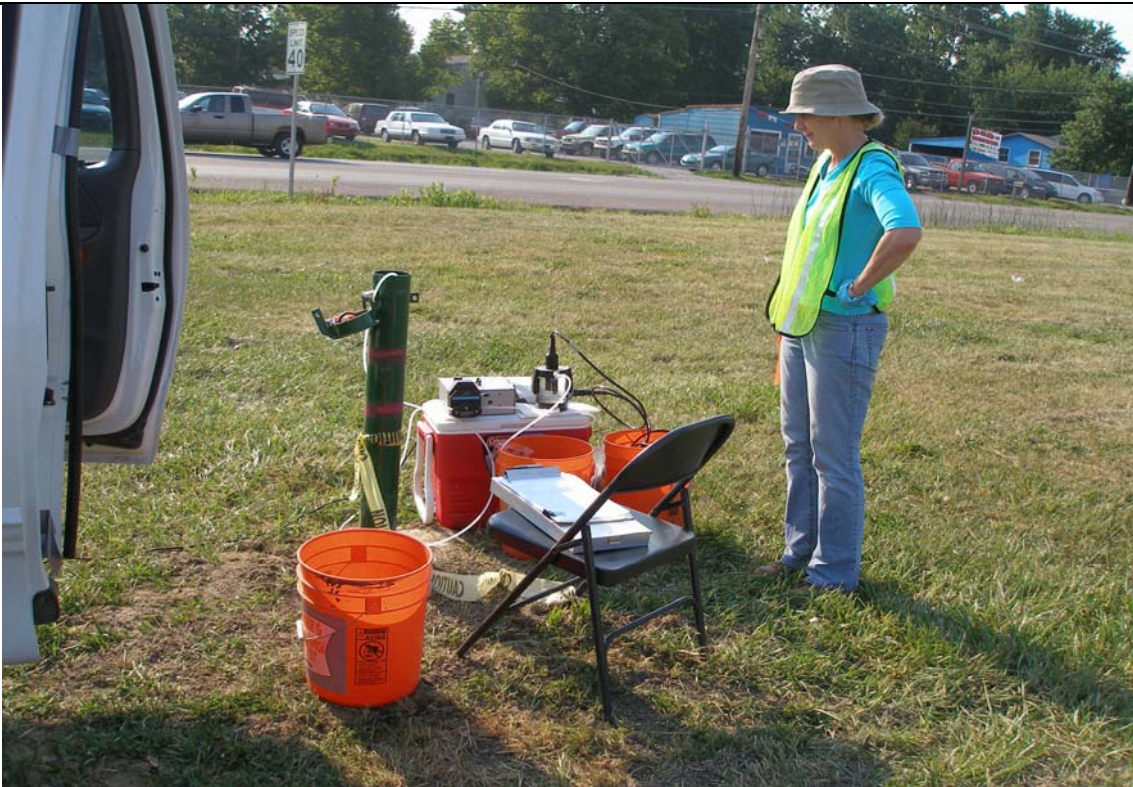
PHOTOGRAPH:		PHOTOGRAPHER:	Melanie Gotto
DATE/TIME:	7/7/2006	8:19 AM	
PROJECT:	Remedial Investigation Report for the Old American Zinc Plant Site, Fairmont City, Illinois		
SUBJECT:	Groundwater sampling activities using the YSI, flow-through cell, and peristaltic pump conducted at MW-01.

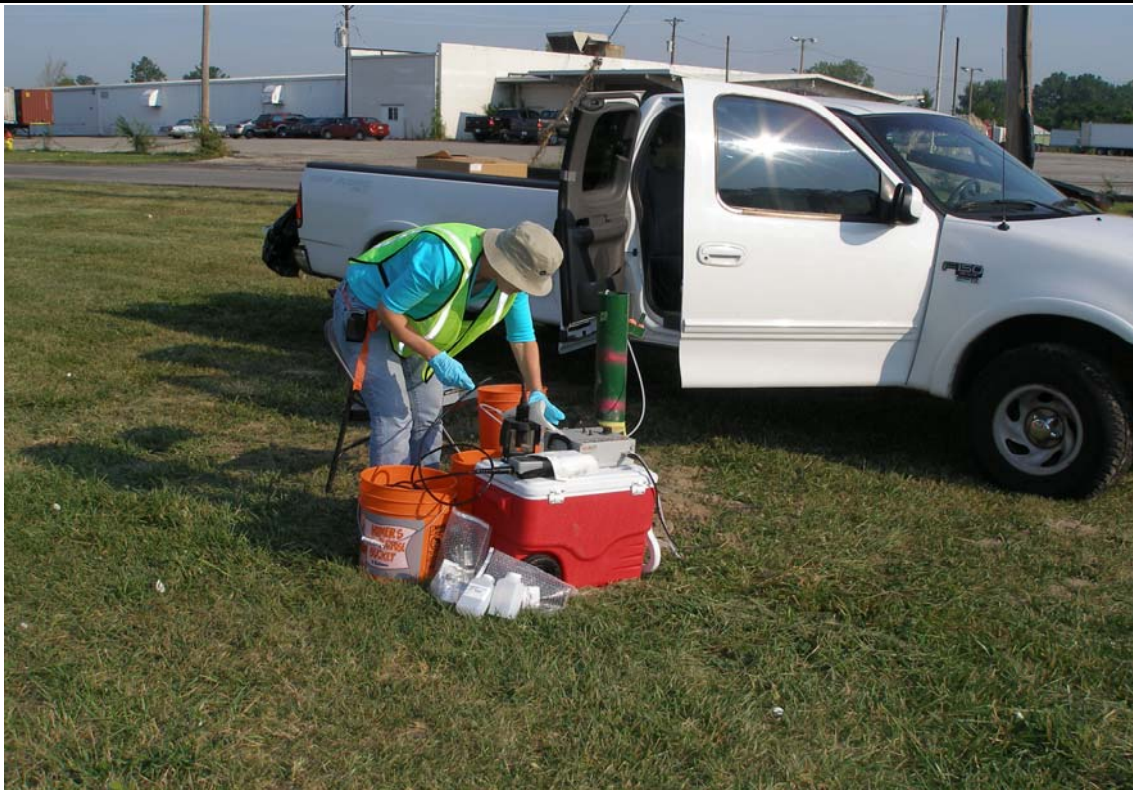
PHOTOGRAPH:	18	PHOTOGRAPHER:	Jeff Stofferahn
DATE/TIME:	7/7/2006	8:18 AM	
PROJECT:	Remedial Investigation Report for the Old American Zinc Plant Site, Fairmont City, Illinois		
SUBJECT:	Groundwater samples were collected via low-flow peristaltic pump.

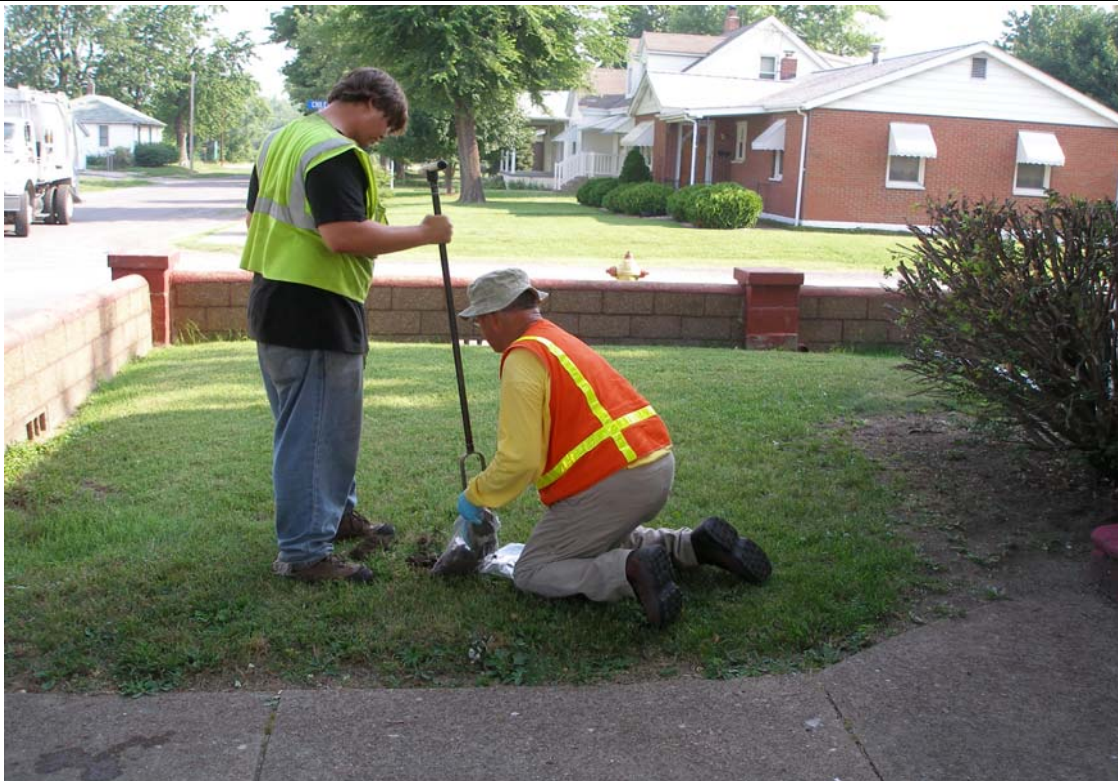
PHOTOGRAPH:		PHOTOGRAPHER:	Melanie Gotto
DATE/TIME:	6/22/2006	8:57 AM	
PROJECT:	Remedial Investigation Report for the Old American Zinc Plant Site, Fairmont City, Illinois		
SUBJECT:	Collection of five-point composite sample at residential property.

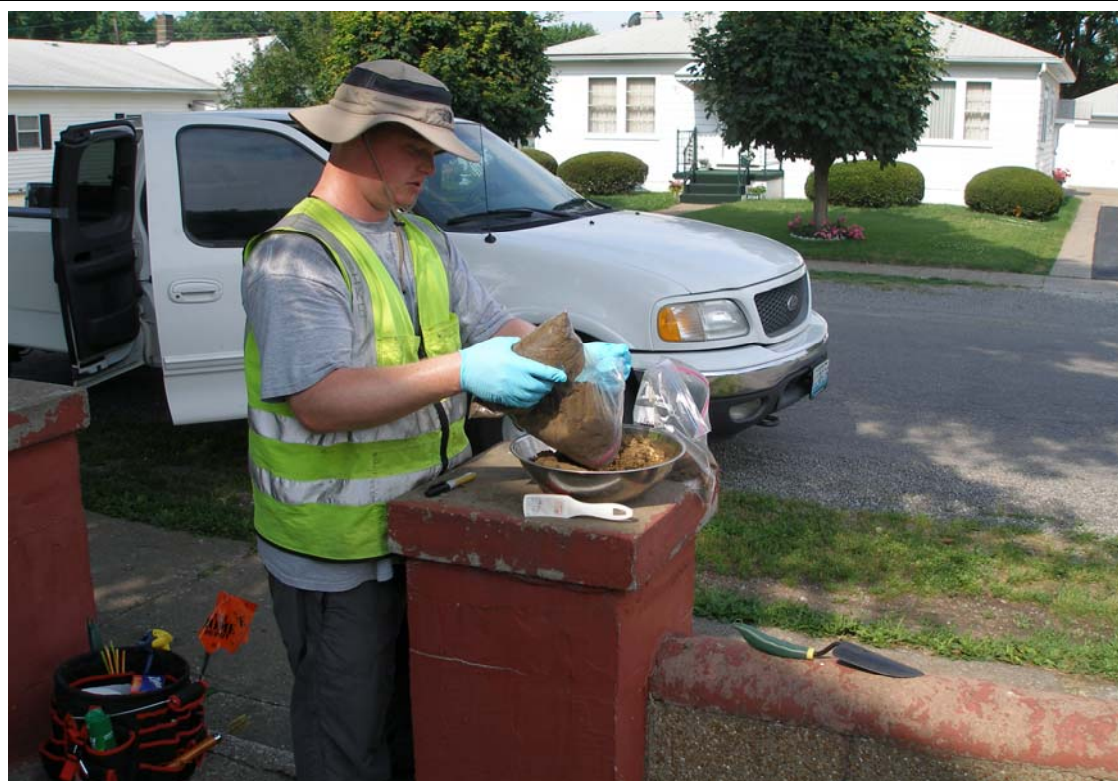
PHOTOGRAPH:		PHOTOGRAPHER:	Melanie Gotto
DATE/TIME:	6/22/2006	9:31 AM	
PROJECT:	Remedial Investigation Report for the Old American Zinc Plant Site, Fairmont City, Illinois		
SUBJECT:	Homogenizing composite sample from residential property in stainless-steel bowl.

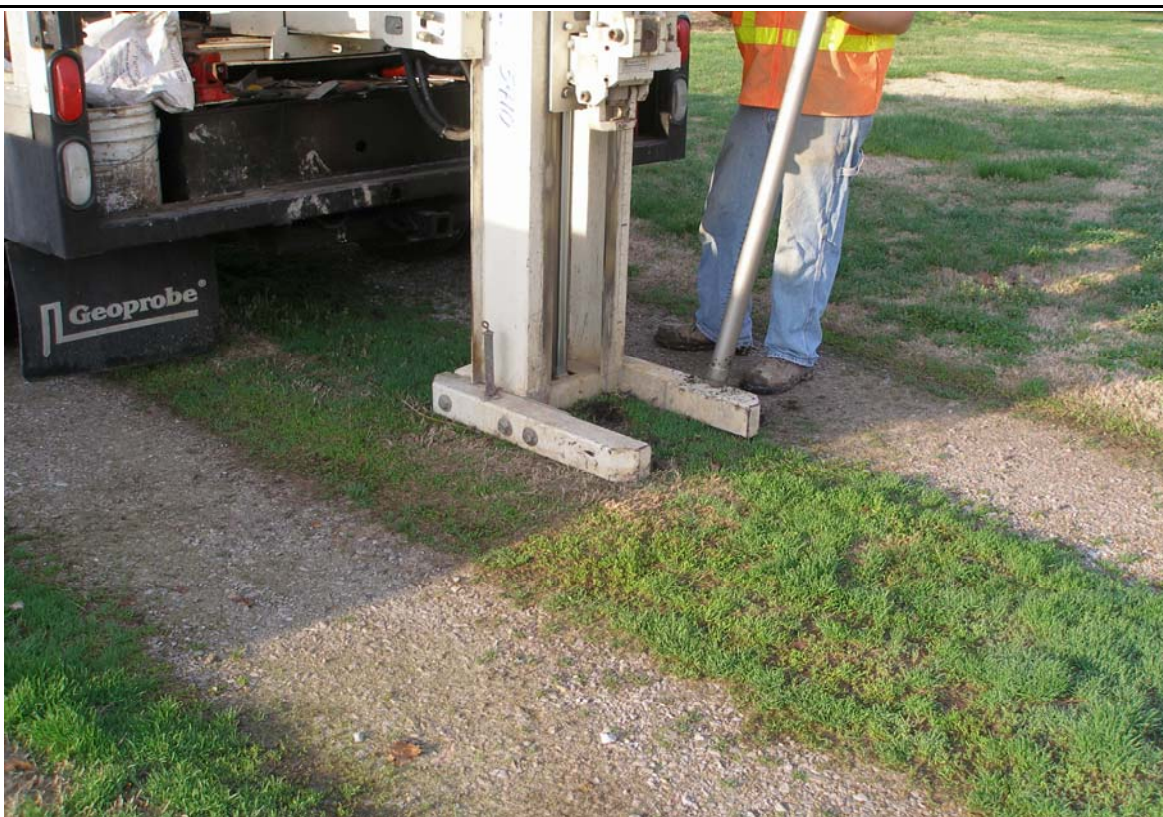
PHOTOGRAPH:		PHOTOGRAPHER:	Melanie Gotto
DATE/TIME:	3/27/2007	7:10 AM	
PROJECT:	Remedial Investigation Report for the Old American Zinc Plant Site, Fairmont City, Illinois		
SUBJECT:	Alleyway sampling in Alleyway Transect (AT)-8 using a Geoprobe.

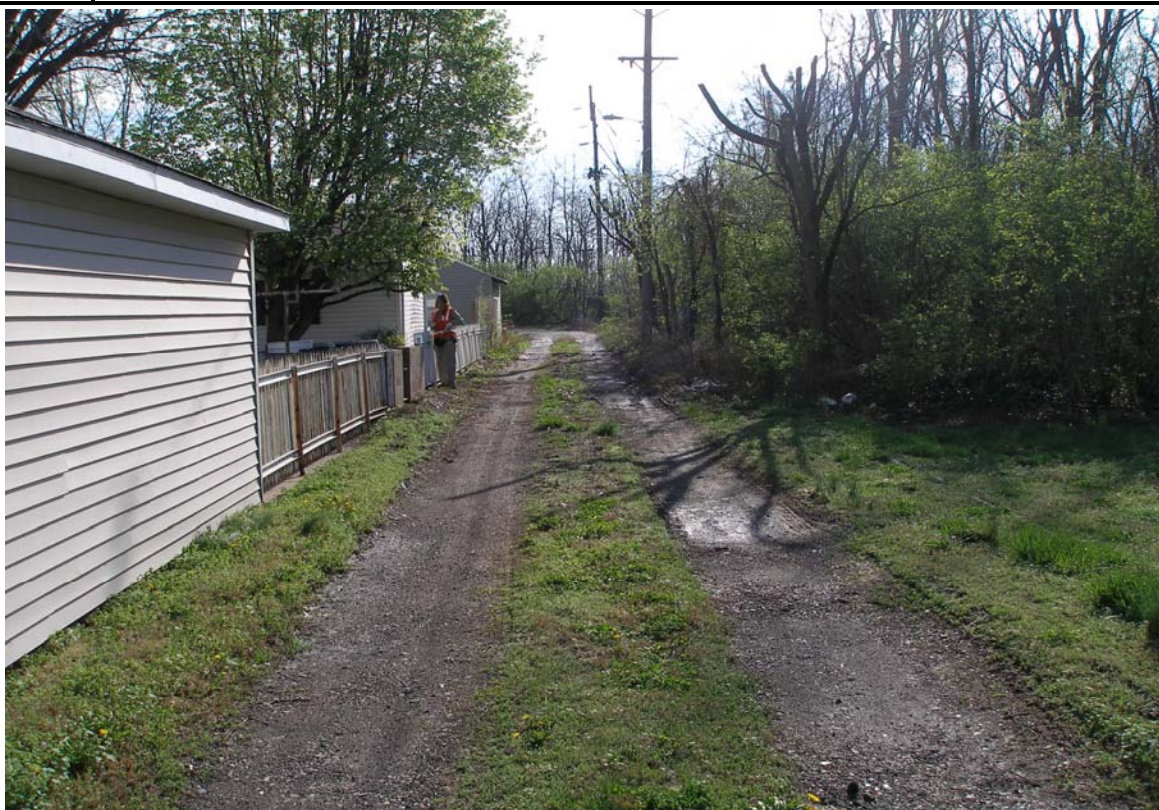
PHOTOGRAPH:		PHOTOGRAPHER:	Melanie Gotto
DATE/TIME:	3/28/2007	8:11 AM	
PROJECT:	Remedial Investigation Report for the Old American Zinc Plant Site, Fairmont City, Illinois		
SUBJECT:	Looking east down AT-5 showing typical alleyway in Fairmont City, IL.

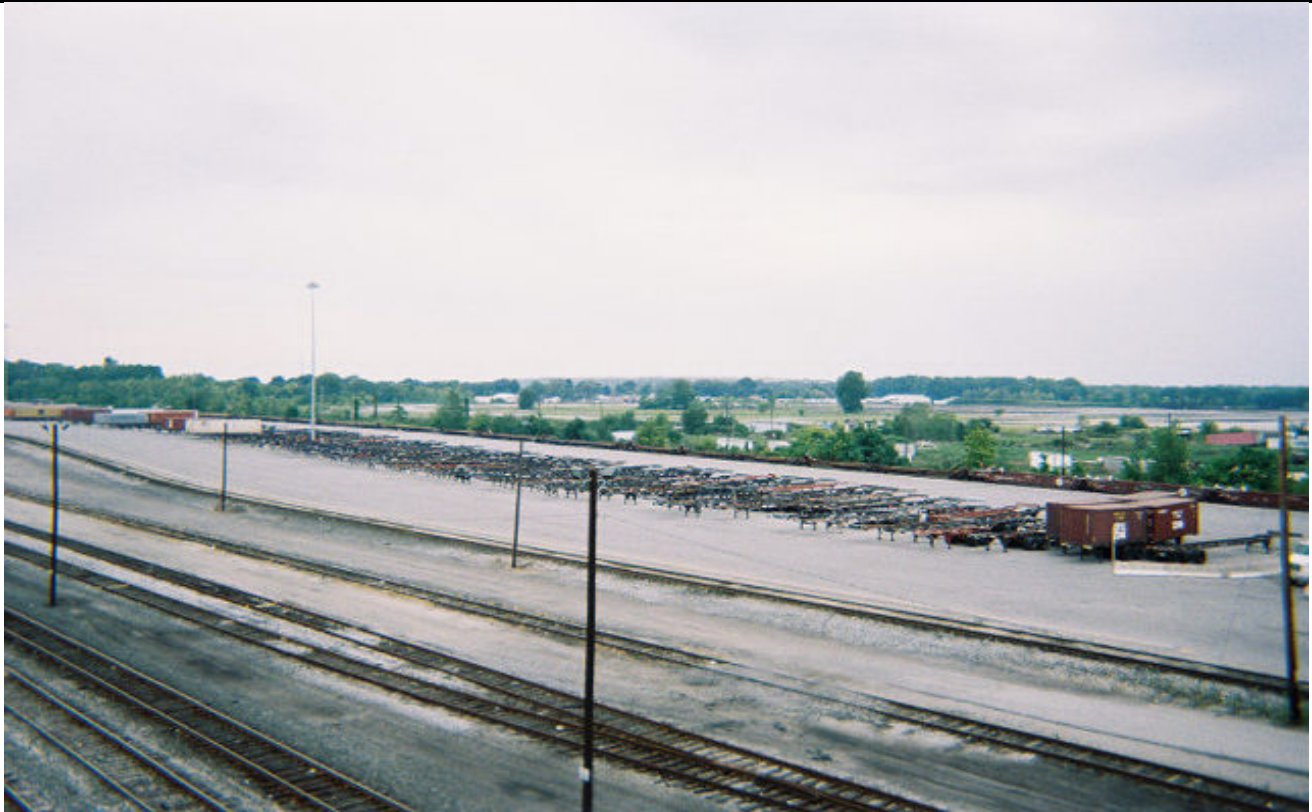
PHOTOGRAPH:		PHOTOGRAPHER:	Melanie Gotto
DATE/TIME:	8/24/2005	1:00 PM	
PROJECT:	Remedial Investigation Report for the Old American Zinc Plant Site, Fairmont City, Illinois		
SUBJECT:	Looking northwest towards CSX Intermodal operations located adjacent to and south of the Facility.

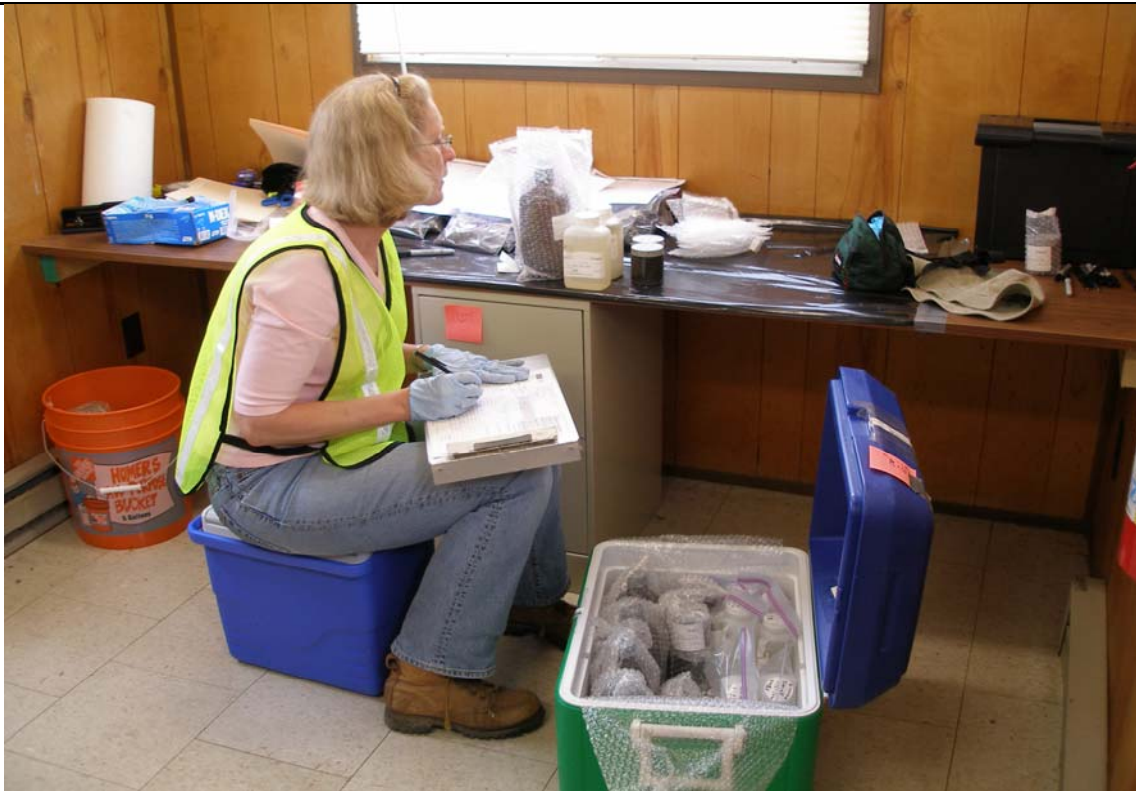
PHOTOGRAPH:		PHOTOGRAPHER:	Melanie Gotto
DATE/TIME:	5/31/2006 2:39 PM		
PROJECT:	Remedial Investigation Report for the Old American Zinc Plant Site, Fairmont City, Illinois		
SUBJECT:	Sample custodian activities conducted in sample trailer located on the Facility.

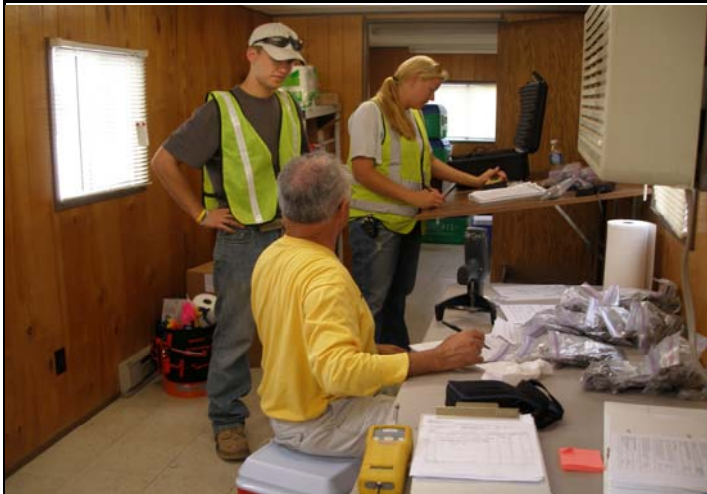
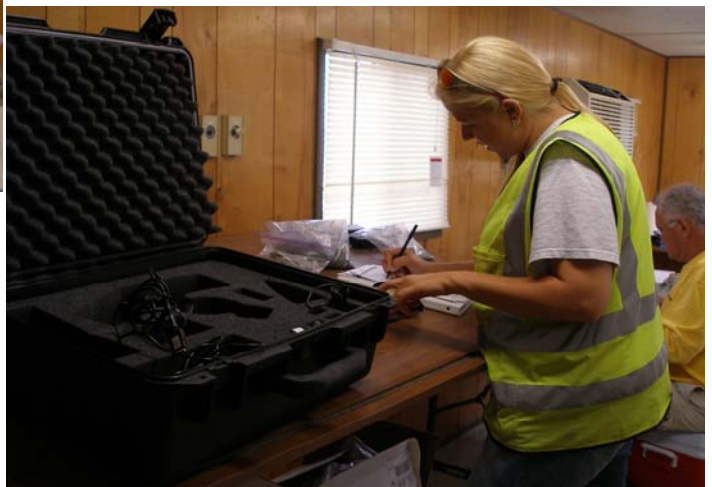
PHOTOGRAPH:		PHOTOGRAPHER:	Melanie Gotto
DATE/TIME:	5/31/2006 2:39 PM		
PROJECT:	Remedial Investigation Report for the Old American Zinc Plant Site, Fairmont City, Illinois		
SUBJECT:	XRF screening in the sample trailer located on the Facility.
